Sunrise Park and Beach

Bluff Vegetative Management Report

P. Clifford Miller, Inc.

July, 2012

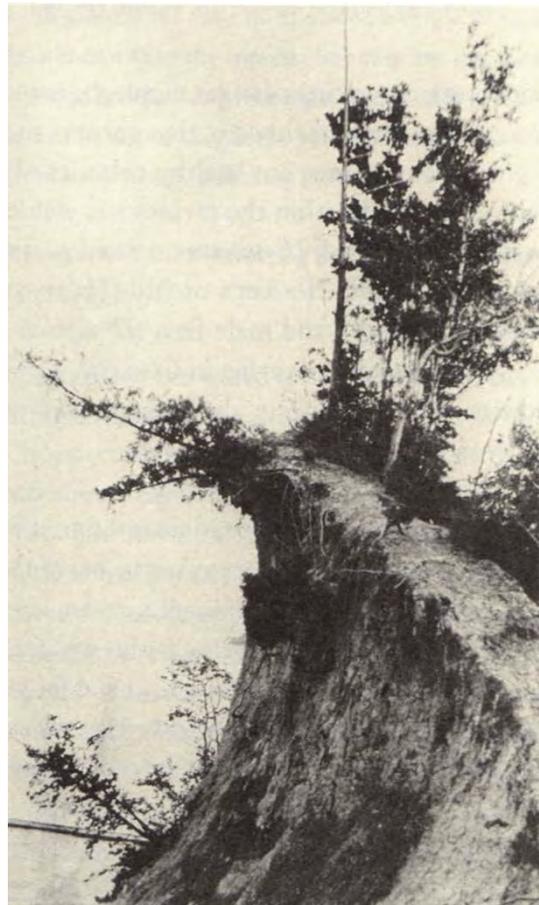
Eroding bluff, Lake Bluff, IL 1913 (courtesy Westchester Township Historical Museum, Chesterton, IN)

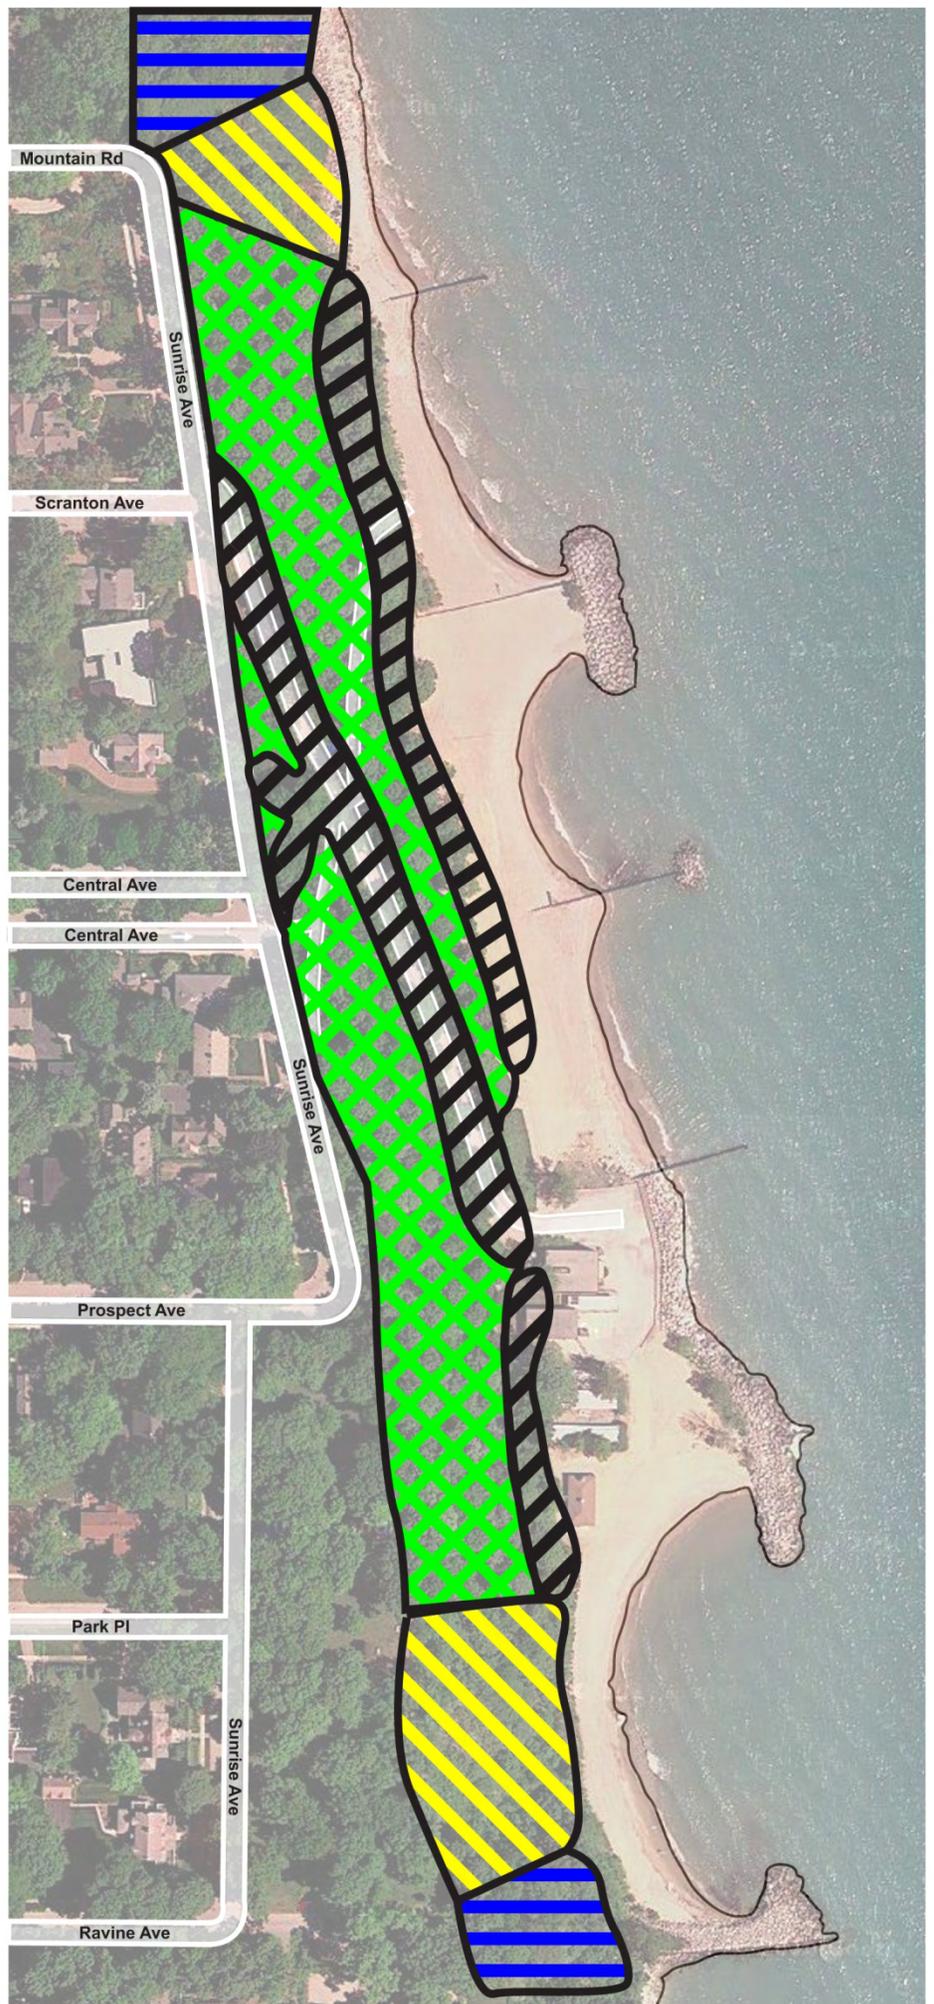
DISTURBANCE ZONES

OLDER BLUFF
SLIPS / REPAIRS

RECENT (1991) BLUFF
SLIPS/ REPAIRS

AREAS DISTURBED
TO PROVIDE ACCESS
& FACILITIES

ORIGINAL GRADIENT

The vegetative communities on the bluff at Sunrise Park vary considerably and in direct relation to past soil movements and disturbances (primarily human). In the broadest of terms, the bluff is dominated by forest, with shrubby meadows to the north and south. Within these general descriptions are several forms of those plant communities, varying in quality (loosely measured in relation to the extent of the original native forest system present) and diversity. For ease of explanation and to simplify the development of management plans, the author has chosen to limit the descriptions and divide the forested areas into four categories, again defined by quality of vegetation present. The meadows require only a single category.

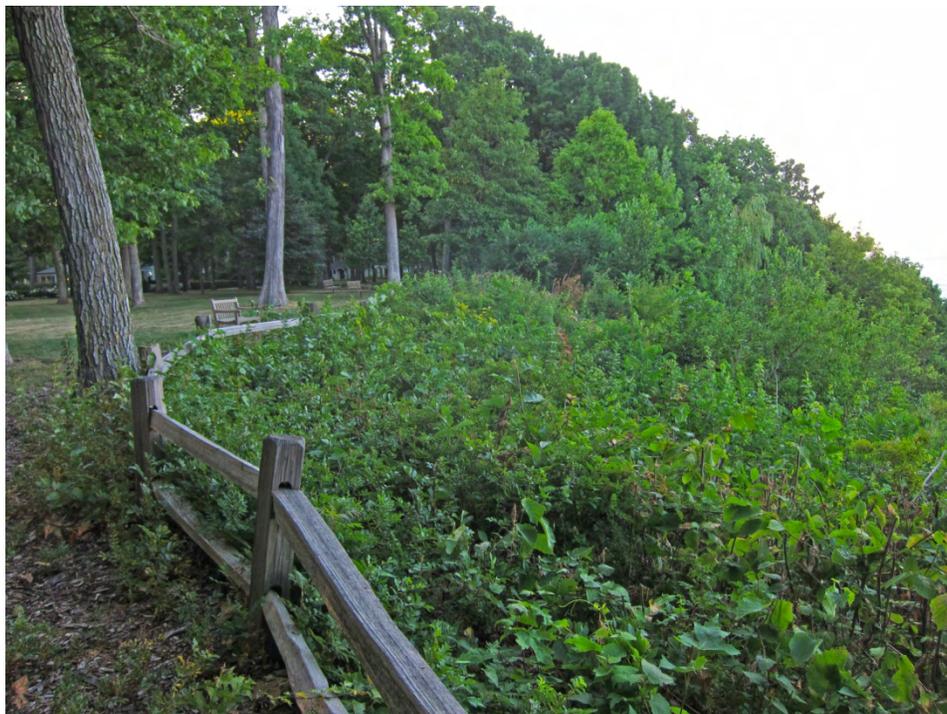
Highly dynamic, these communities consist of successional shrub species such as sumac, hazelnut, dogwoods and willows, along with a scattering of young oaks and other, both native and non-native, aggressive colonizers such as poplar and Norway maple. The herbaceous layer originally contained a diverse mix of native grasses and flowers. This mix of grasses and wildflowers originally occupied the largest areas on the restored bluffs. Today that is no longer the case, as the shrub layer has taken over the majority of the meadow, and what is left is dominated by aggressive colonizers, especially the northern unit. Crown vetch has taken over most of what remains of the open areas, limiting greatly the diversity of the ground layer.

South successional meadow

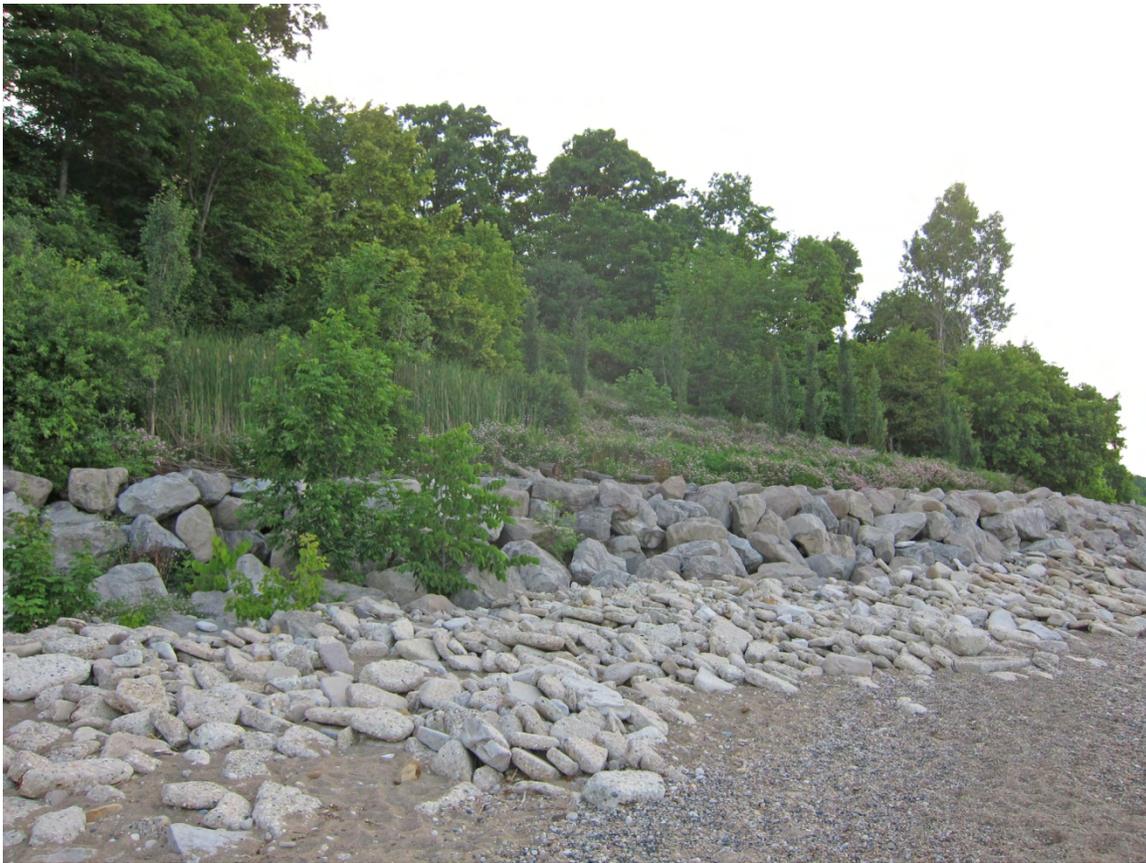
Of particular interest is the small perched wetland present in the southeast portion of the northern meadow. Primarily colonized by cattails, the presence of this system, just above the large stone revetment, is a clear indicator of the amount of ground water moving through the bluff, rather than over it. It is this hydrating of the glacial till, primarily clay, both from rain and from ground water moving out through the bluff along interfaces in the soil profile, which causes much of the movement associated with bluff erosion. Of course, the biggest culprit in the erosion of the bluffs historically is Lake Michigan, which literally takes the feet right out from under them.

Cattails in seep

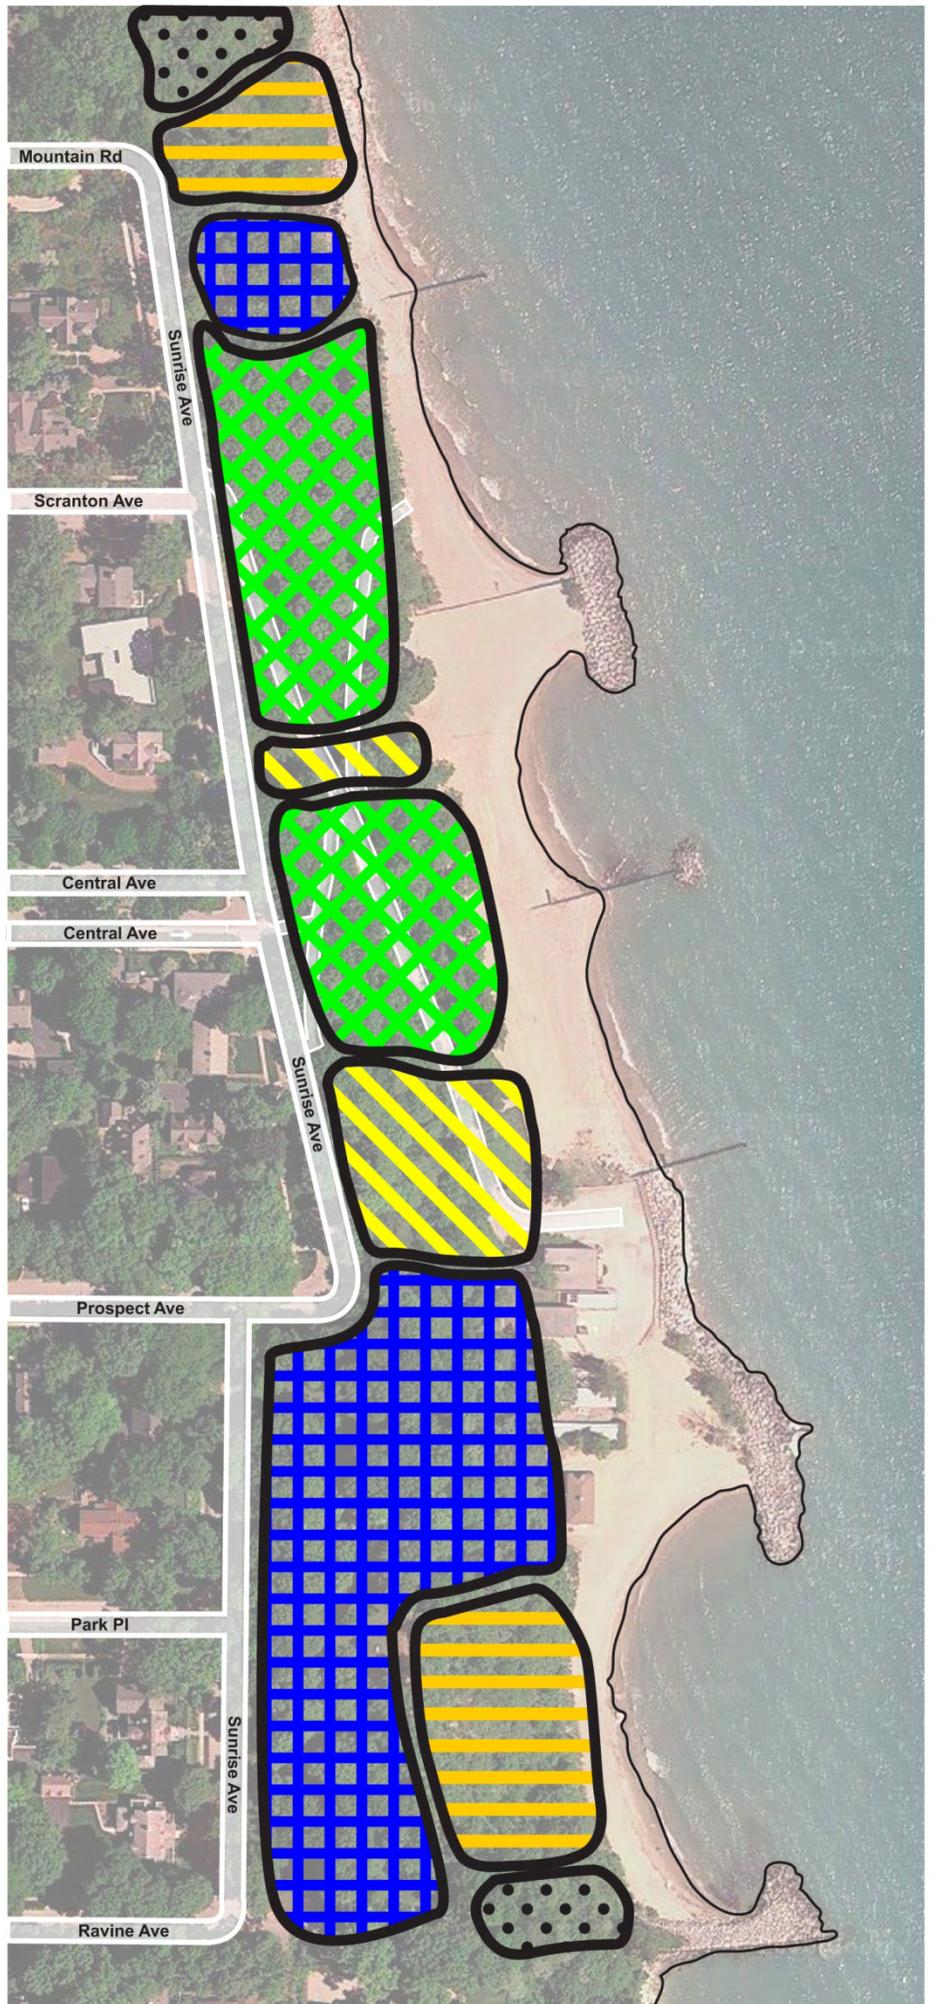
PLANT COMMUNITIES & MANAGEMENT ZONES

SCRUB WOODLAND
 poor quality canopy
 & understory
-

MESIC FOREST "C"
 low quality canopy
 & understory
-

MESIC FOREST "B"
 better quality canopy
 low quality understory
-

MESIC FOREST "A"
 better quality canopy
 mixed quality understory
-

SUCCESSIONAL MEADOW
 emerging canopy
 mixed quality understory

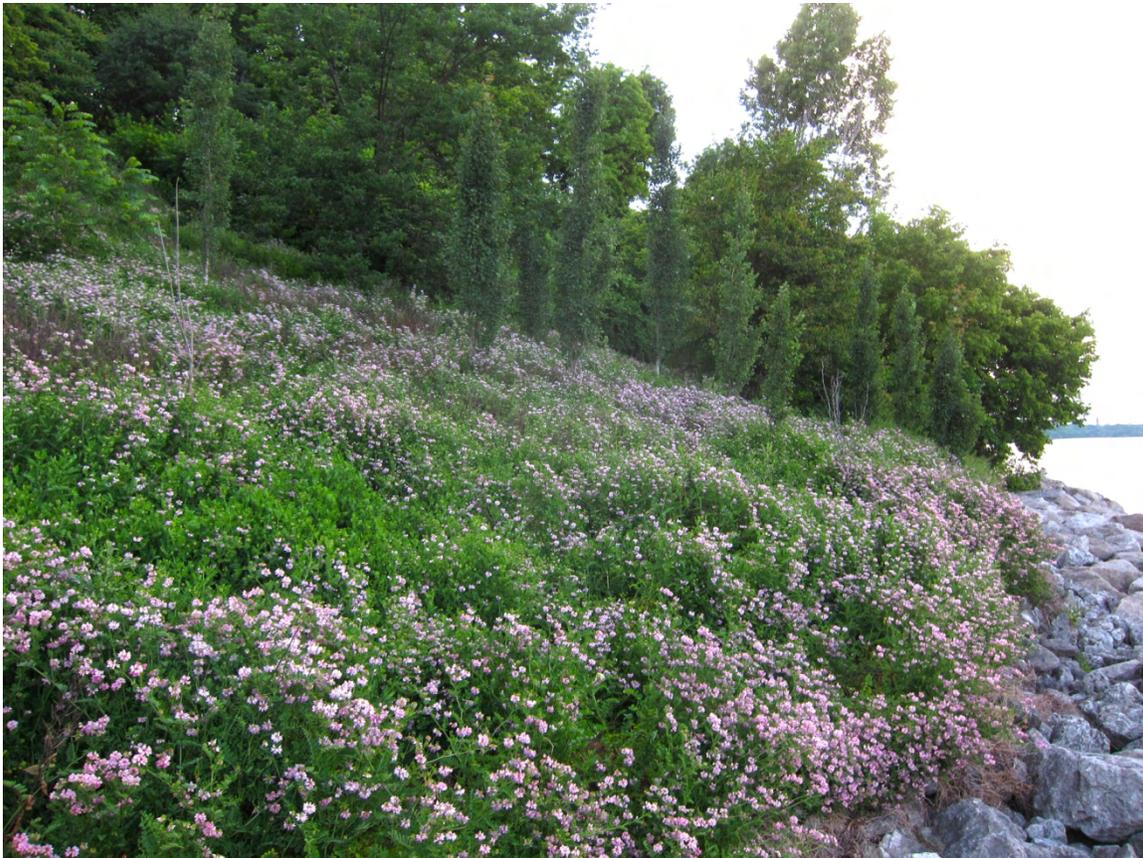
Crown vetch in north successional meadow – note hybrid Lombardy poplars

The reason for controlling the vetch is similar to what has been discussed previously—a monoculture is less desirable and potentially problematic. Unlike the forested slope where monocultures of other herbaceous plants exist within a community of understory and canopy trees, providing a mix of size and depth of root systems, vetch can, and has, effectively wiped out most other flowers and grasses in its path, becoming the only plant found on portions of the slope. Although the plant has a strong root system, it isn't very deep compared to some of the other forbs, and, by being the only plant growing in certain sections, the root system occupies pretty much the same plane in the soil profile, leaving the ground susceptible to sudden slips along the line of average root penetration. The author has seen this situation on highway embankments with vetch as well as with monocultural stands of grasses. Although crown vetch makes a poor component of a fuel matrix for controlled burns, it is matt forming and thought by some to be effective in preventing the establishment of woody invasives. This theory is supported by the existing conditions found at the lower end of the north meadow, where very few woody plants have managed to penetrate or become established amongst the vetch. Also, vetch likely reduces the impact of falling rain effectively as a result of its vegetative density.

Again, recommended management is to keep it in check, slowly knock it back, and perhaps introduce other plants into the middle of it to increase variation in the depth of root penetration. Some success with this has been shown with the use of native switchgrass, which is already present on the site.

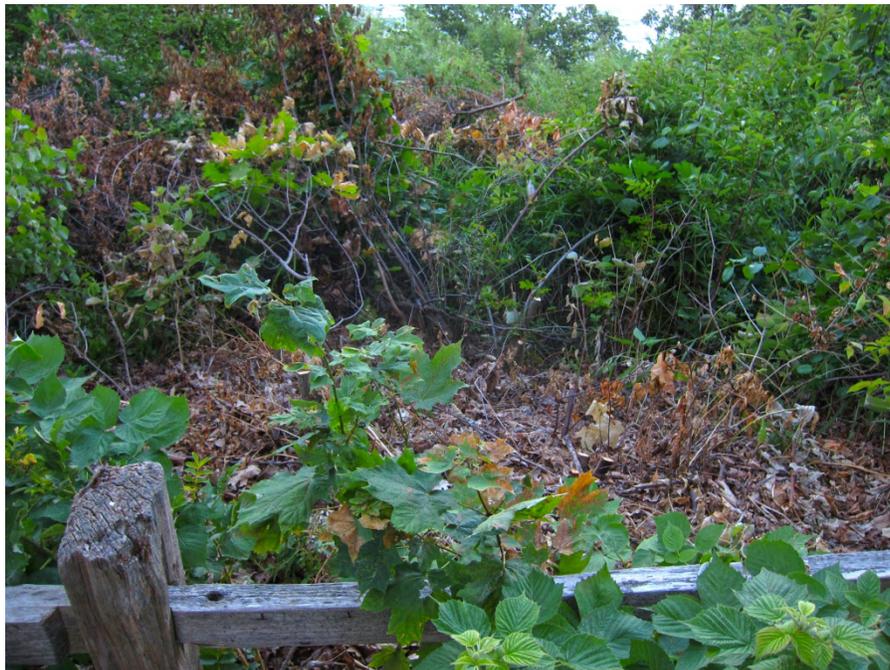
Recently cut young oaks south successional meadow

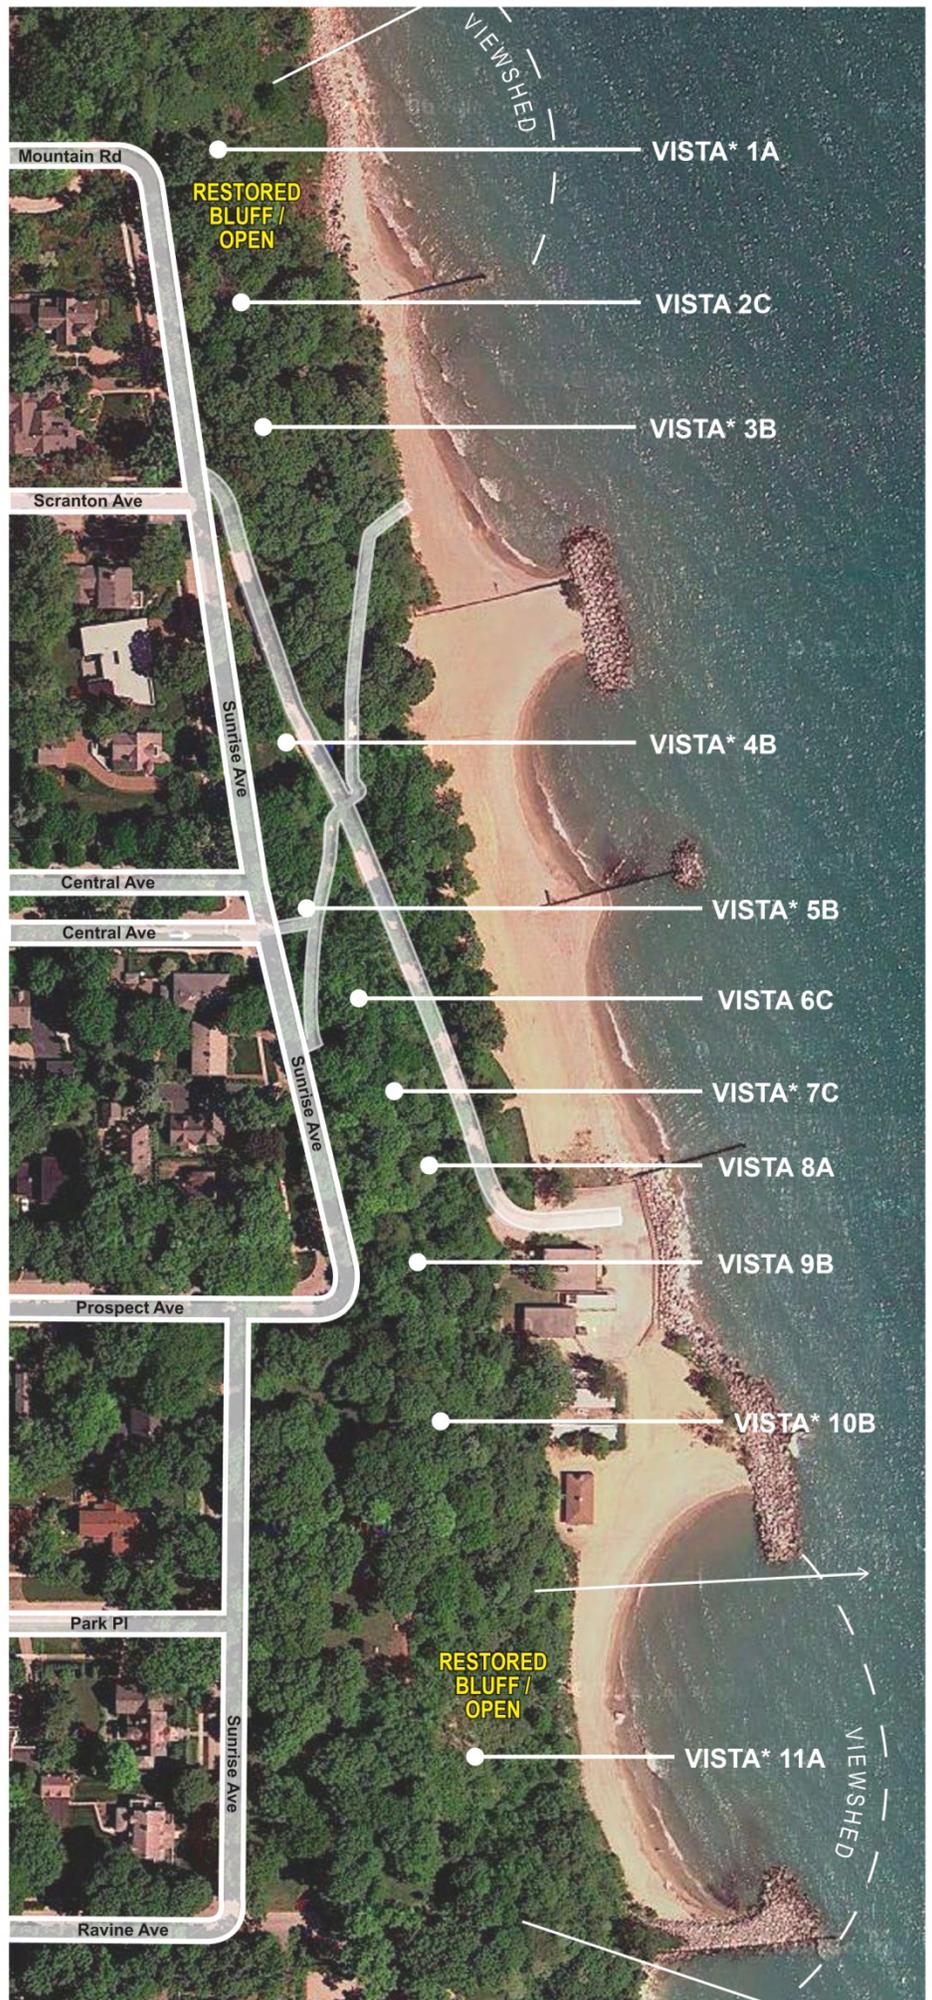
BLUFF VISTAS

- A - OPEN VIEW
- B - PARTIALLY OPEN VIEW
- C- LIMITED VIEW

* Indicates originally proposed vistas

The vistas cut out of the existing forest vary in size from ‘intimate windows’ with limited viewsheds, to open and clear vistas of the beach, lake, and beyond. The size of these openings has been dictated primarily by the level of clearing and cutting necessary to create them, and to a lesser extent, location. It is important to mention that another factor taken into account is the quality of the forest in which the openings were created. Only two of the vistas are in the higher quality woodland. The Bluff Vistas graphic shows the location and type of each opening.

It is recommended that the vistas be maintained as they currently exist, although consideration should be given to minimizing or eliminating the vistas in the Mesic Forest “A” zone and perhaps abandoning Vista 7 and 9, as the central section of the Park has the highest density of openings and neither is significant. A final review may be warranted.

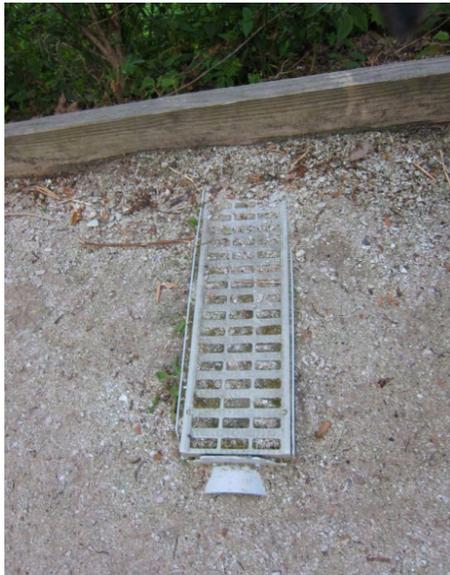
As an aside, it was interesting to note just how effective the plantings of the various types of thorn bushes on the top of the bluff over the years were in controlling pedestrian access, which was previously a much larger problem. The fence was added later, perhaps as part of the restoration of the bluff. Controlling the flow of pedestrian traffic down and through the bluff is an important element in the management of the surrounding vegetation. Also, the drain system built into the lower gravel and timber pathway is totally non-functional and should be repaired or replaced if necessary.

Non-functioning drain

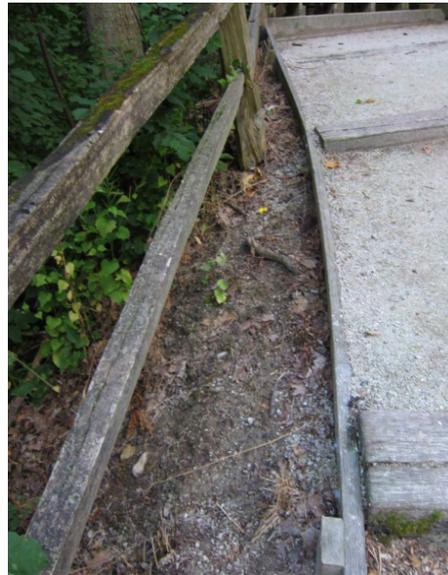
Aside from the stairs, pedestrian pathways down to the beach are primarily gravel and timber. Surprisingly, the vegetation along these pathways, especially up near the top, is diverse and many high quality native plants are found. The paths are simple, wide, and adequate for most foot traffic. The vegetation is worn out on the sides of the path but nothing excessive or requiring action, other than maintaining the gradient. Near the bottom, above one of the shelters, there is a worn path down the face of the slope and at the very top, above the gravel walk where the split rail fence ends on a point, another, less noticeable path exists. Both can be controlled with additional fencing and restored with simple plantings. The lower eroded path is more serious and likely to lead to bigger maintenance issues regarding the main path if left untended. The small timber retaining wall can be dealt with at the same time. Adding a section or two of fencing on the tableland to extend the existing and beefing up the lower fence in the area of the main erosion should help lessen the damage and allow for vegetative restoration.

Eroding path edge

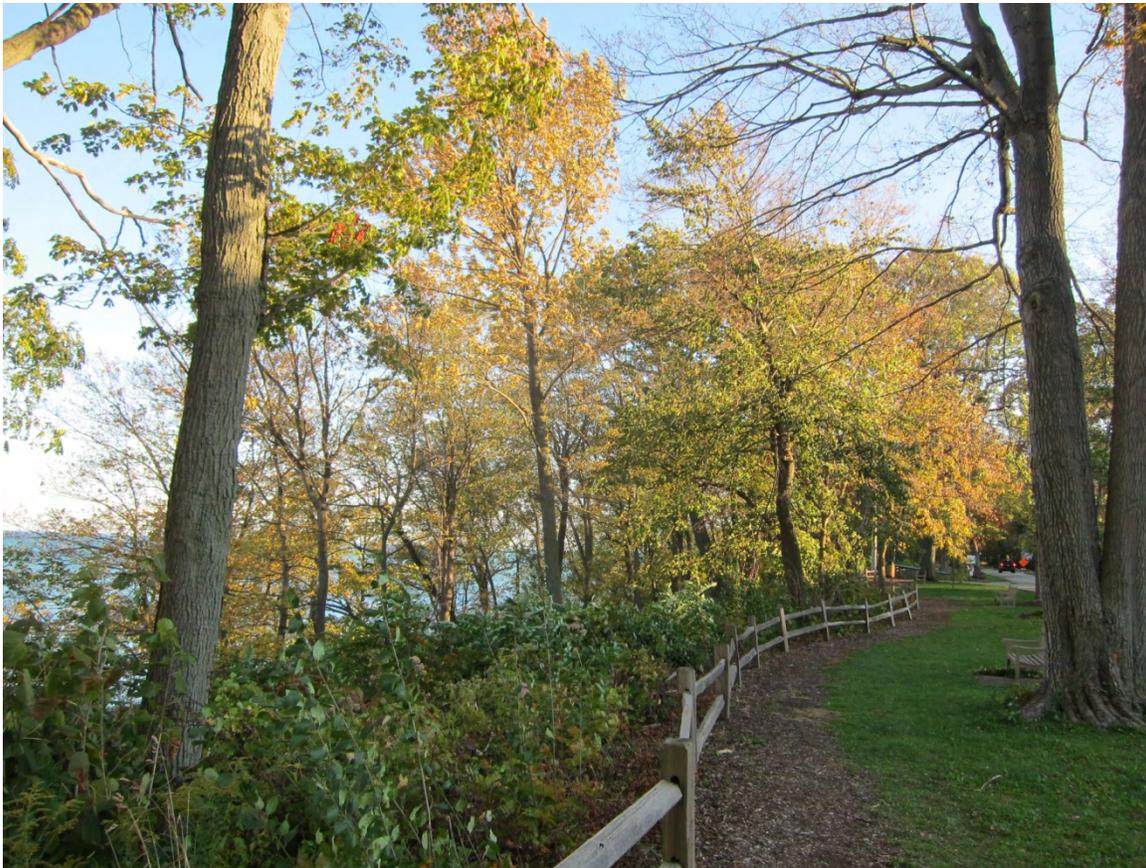
As the woodchips break down and subsequent layers of new chips are added, the tendency is for this type of path to become a thick spongy layer of organic matter, capable of retaining a surprising amount of water. Also, the chips tend to spread and the path begins to slowly expand and some of the chips begin to migrate and build up along the fence and the edge of the bluff, where they merge with the areas of heavy leaf deposition from the previous fall. More often than not, leaves end up being blown over the bluff rather than into the truck. The end result is a loss of vegetation along the fence and top of the bluff. It would be an improvement to first remove the old chips and organic matter before placing new chips, or better yet, change the path material to gravel. An added benefit: it would be a lot easier to spot the dog feces on the gravel than it is on the chips.

Woodchip path and split rail fence

At the very least, the path should be moved a minimum of two feet off the fence line to allow for the vegetation to hold tight on the bluff crest. Moving the path and replanting the buffer zone is the recommended course of action. This will also make it easier to monitor leaf deposition in the fall. Along those lines, it would add visual interest and be beneficial to several of the tableland trees if the bluff vegetation was allowed to come up and across the path here and there along the walk, perhaps encompassing a few groups of trees along the way. This would allow for an expansion of the native woodland vegetation and strengthen the connection to the forest by the Park user, who would not just be walking along, but now walking through, portions of the forest. The canopies of the tableland trees are connected to the trees on the bluff. It would be easy to connect the understory—and perhaps the recommended tree planting plan for the tableland could show this.
